LIQUIP INTERNATIONAL PTY LTD - ENGINEERING DEPARTMENT - 13 HUME RD SMITHFIELD SYDNEY NSW AUSTRALIA 2164  
PH: +61 2 9725 9000 FAX: +61 2 9609 4739 EMAIL: engineering@liquip-nsw.com.au

## TECH TALK: 0071 LEAKAGE TEST - ERP101 & EMH600H

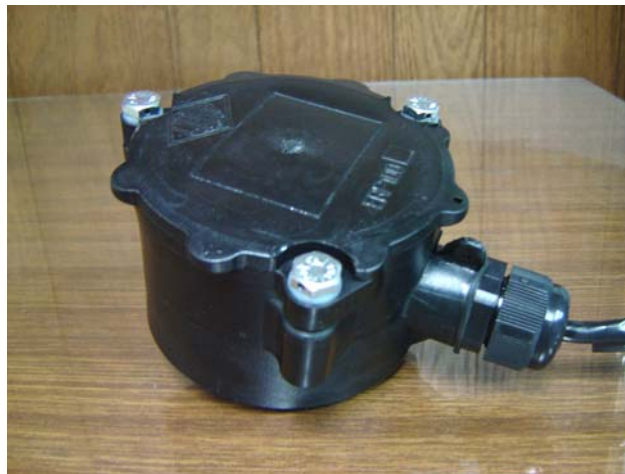
- ERP101

The ERP101 cable gland demonstrated good sealing, since there were no signs of water ingress. The o-ring around the cap was also found to be very adequate in sealing the unit.

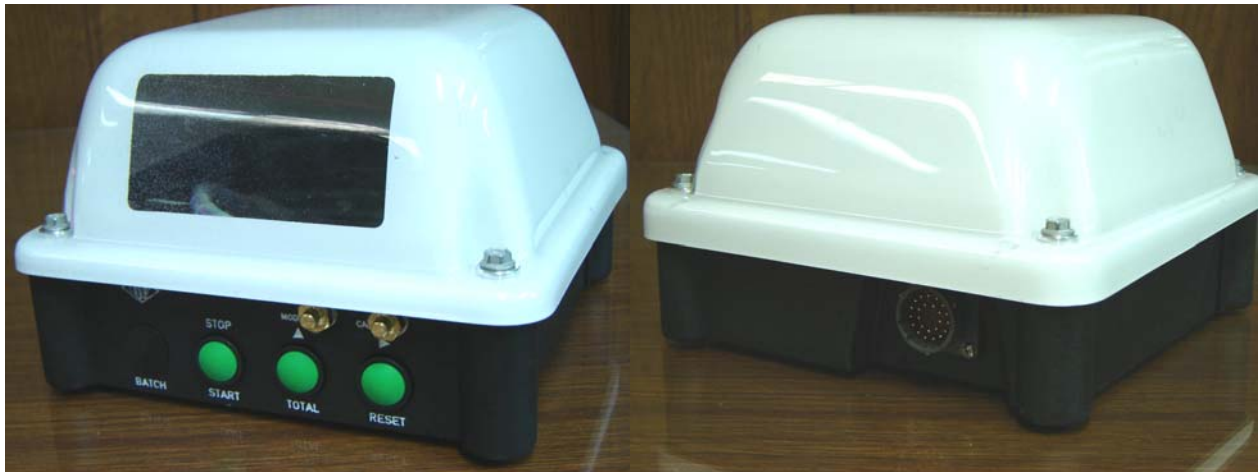
- EMH600H

Before assembly, the tolerances were checked for the button assembly to make sure it was within our specifications. The tolerances were found to be correct. The unit did not show any water ingress in each test.
